**Lot 23 Brockman Highway,
Nannup
Askino Subdivision**

**Dilapidation Survey and
Subdivision Engineering
Report**

FOR THE SHIRE OF NANNUP

12 July 2010

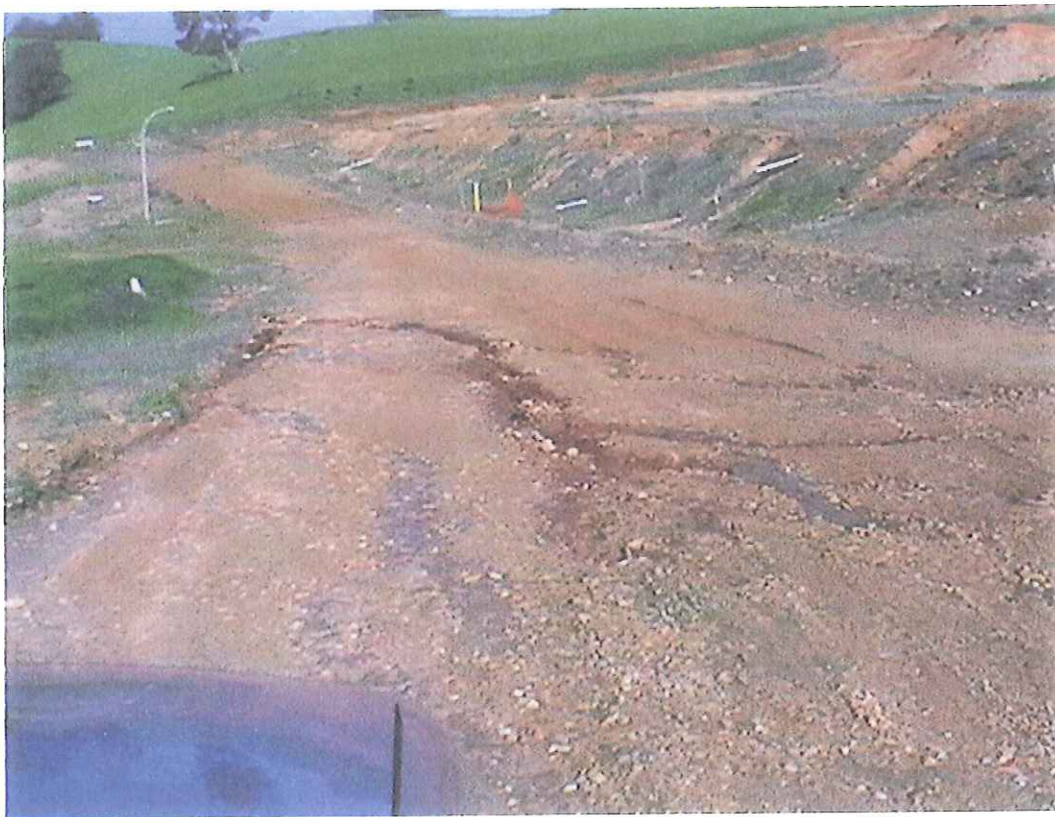
Figure 2. Pavement Damage opposite POS

The condition of the pavement is generally sound. There are two sections which are in poor condition however, the first being in Hitchcock Drive mid-hill (Figure 4.) and the second being over the top of the crest continuing past the Public Open Space.

In the first location sub-surface water has penetrated the pavement wrecking this section of road. It is not clear whether there are any springs under the roads, whether the uphill service trenches that are filled with sand have tracked water in and under the pavement, or whether surface water has penetrated under the footpath and then under the pavement. In any case remedial installation of sub-soil drainage is needed to intercept the water and direct it into pits to prevent it from coming under the road.

Subsoil pipe should be adjacent to the footpath (clear of services) in the three locations shown below. The mid-hill subsoil should cross the low side of the pavement failure and finish in the existing pit. This will assist removal of water from under the pavement in this location. Each subsoil pipe should be 100mm diameter

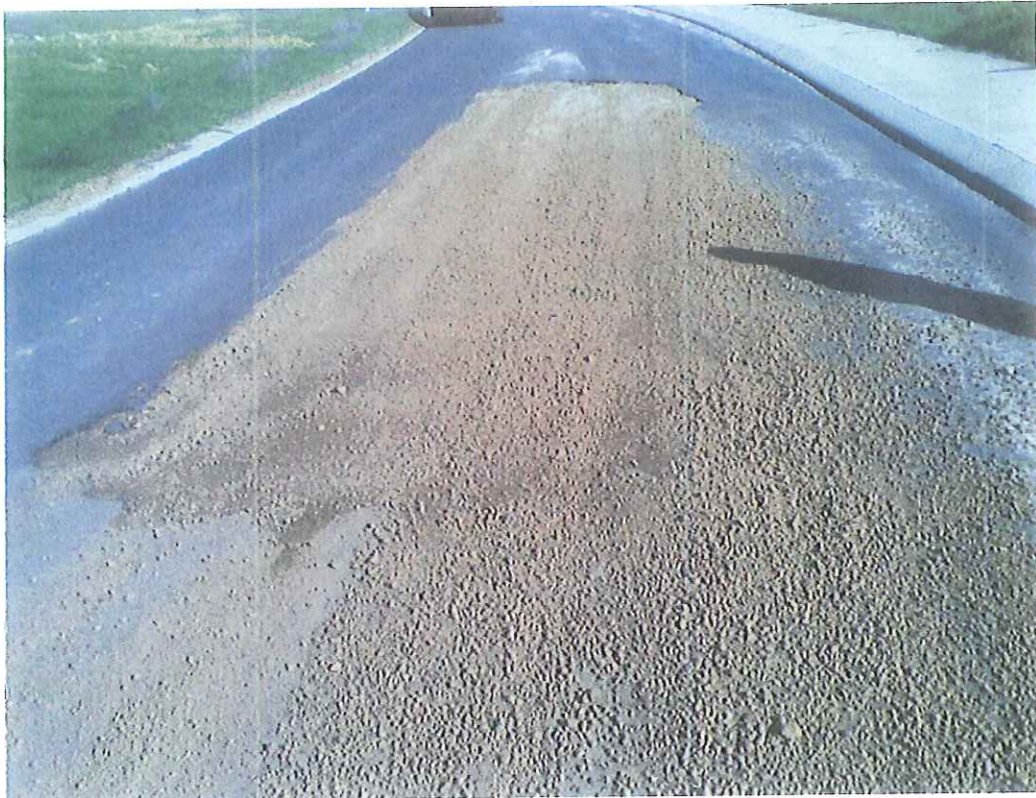
Figure 4. Pavement Damage Severity 3

While the surface washout is obvious in Hitchcock Drive, there is also pavement deformation against the right hand side kerb (right looking up the hill), running up the hill. This is very likely related to ingress of water and vehicular traffic on the road. Heavy vehicles account for much more damage to pavements than do cars, particularly in relation to pavement deformation.

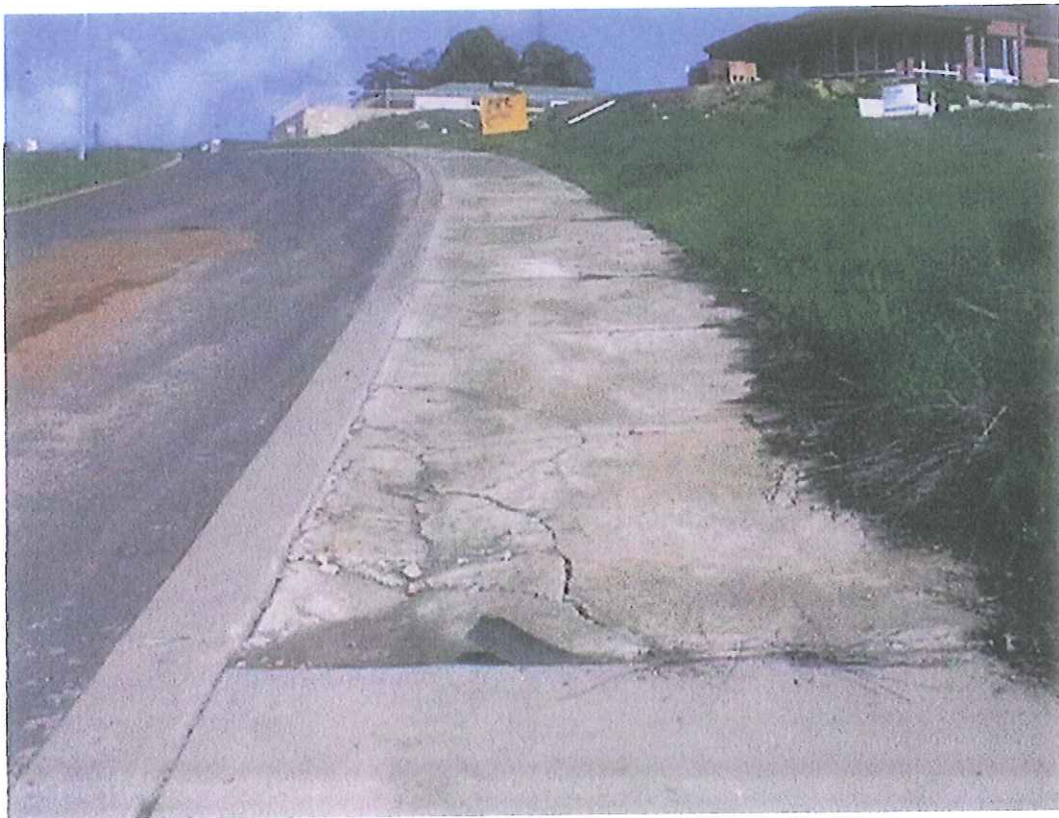
Figure 5. Footpath Damage Severity 3

The damage to the pavements, footpaths and verges within the subdivision is largely due to water intrusion. Surface water has caused extensive scouring of the verges and has washed soil onto the roads. It has undermined sections of footpath leaving them without support and it has eroded verges leaving deep channelling.

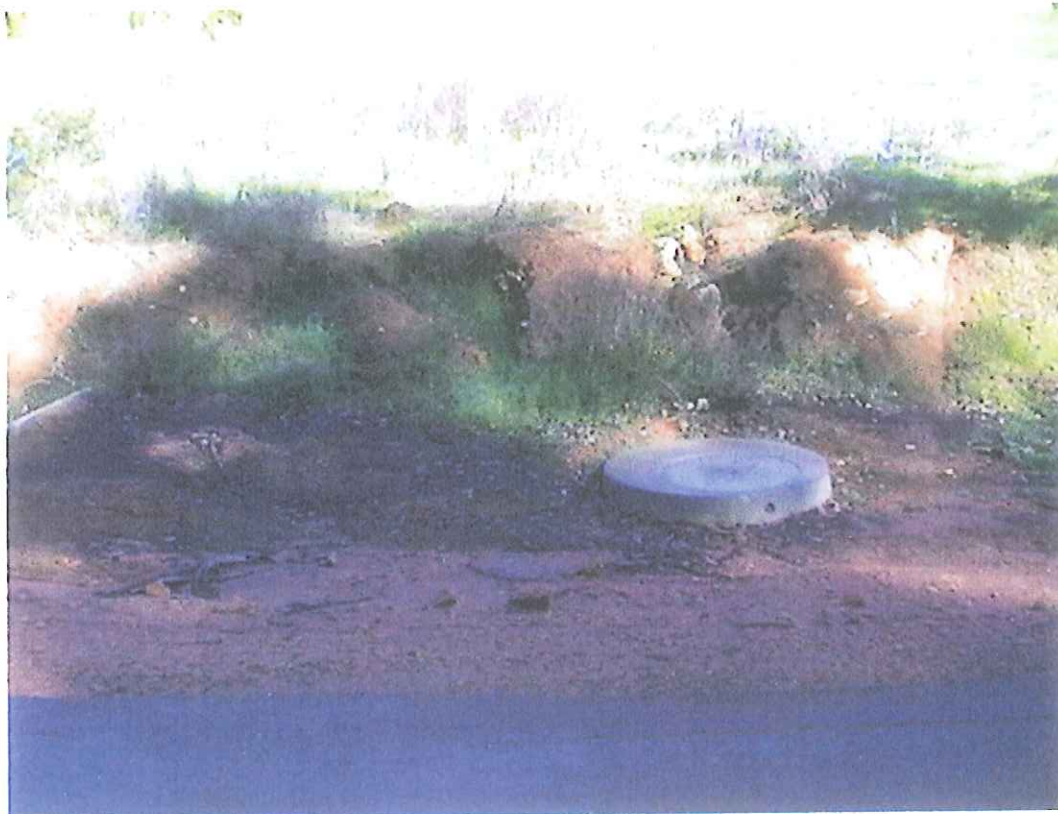
Figure 8. Erosion Adjacent to Brockman Hwy

While erosion has been listed as severity 3 in some cases, it will be difficult to repair the damaged areas during winter. In this case then appropriate pedestrian safety barriers should be installed and the works carried out at a more favourable time.

Erosion control is a major issue for this subdivision. Backfilling of the existing scours areas and protection with a product such as Enviromat (from Geofabrics Australia) to stop further erosion is required. Seeding and watering should be carried out to establish vegetation.

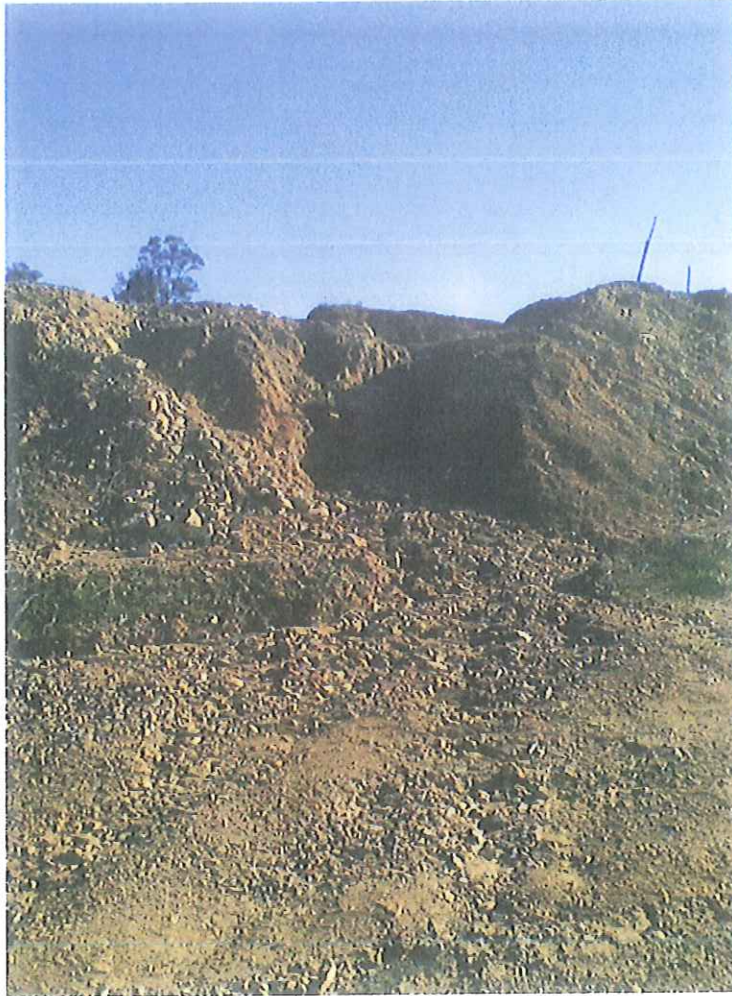
Figure 11. Stage 3 Erosion

A soil stabilization strategy is a standard requirement of the "Local Government Guidelines for Subdivisional Development" Edition 2, 2009. Given the terrain and the current state of the subdivision with respect to erosion, the development and implementation of a soil stabilization strategy is recommended.

- Soil stabilization bond
 - Outstanding works bond
 - Landscape maintenance bond
 - Streetscape maintenance bond
 - Defects liability bond
16. A Soil Stabilization Strategy should be required in order to control erosion, as per the "Local Government Guidelines for Subdivisional Development" Edition 2, 2009.

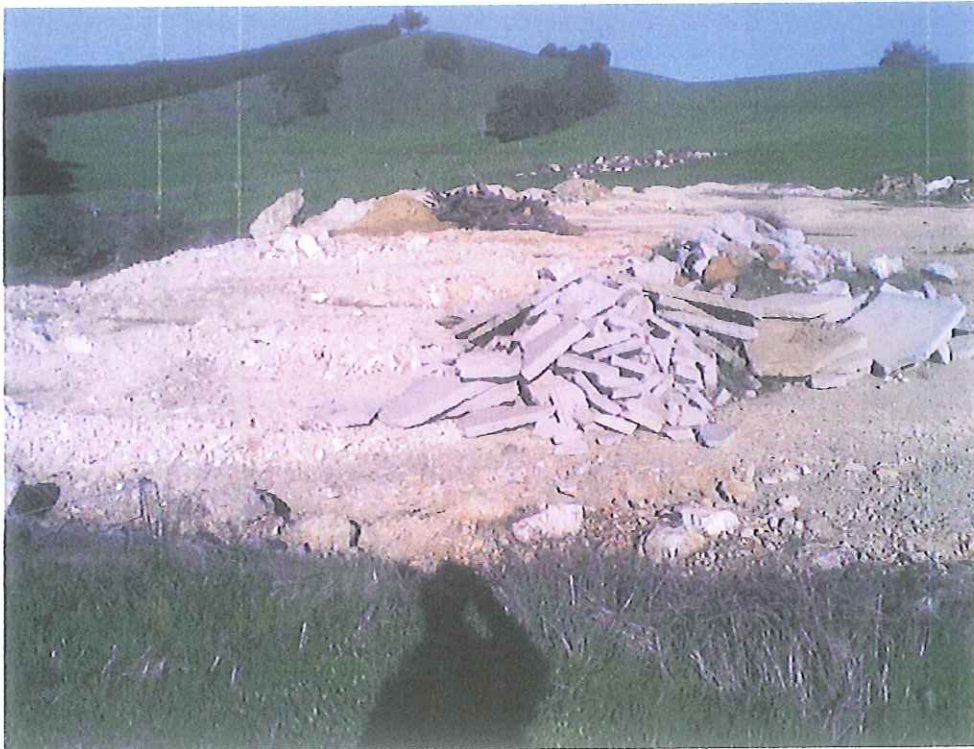
Figure 13. POS Uncontrolled Fill

The Public Open Space (POS) has been used by the Developer as a site for depositing excess fill and rubble and not all of the material being placed in the Public Open Space (POS) is suitable to be located under buildings and other structures. Before any further filling is carried out in the Public Open Space, the final landscaping and use of the building must be determined, including the nature and location of buildings, paths lighting and any stormwater detention.
