**Lot 23 Brockman Highway,
Nannup
Askino Subdivision**

**Dilapidation Survey and
Subdivision Engineering
Report**

FOR THE SHIRE OF NANNUP

12 July 2010

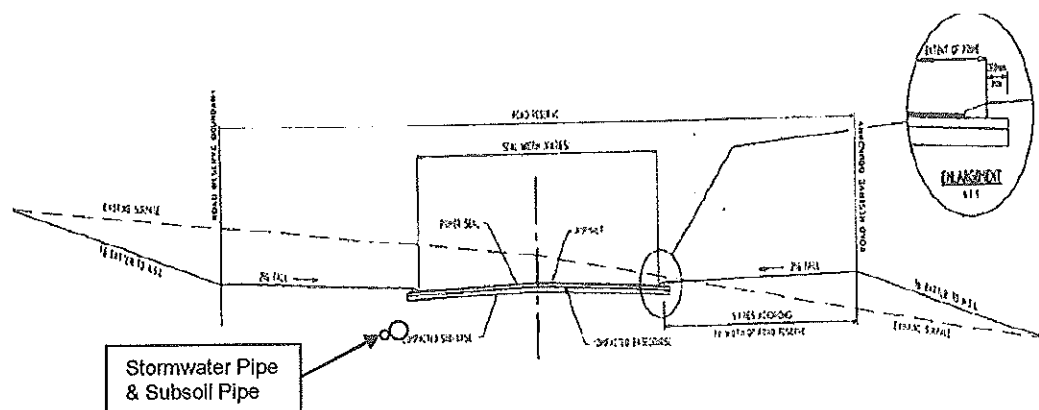
This site, along with others to be developed in Nannup, requires design and construction techniques which differ from that of the Swan Coastal Plain. Hitchcock Drive has been designed as a one way crossfall road with the stormwater drainage running along the downhill side of the pavement. The experience of both Hitchcock Drive and Diggers Green is that sub-surface water has penetrated under the pavement and therefore it is recommended that a different design approach be taken for the remainder of the roads in the subdivision to minimise the likelihood of this problem from re-occurring.

It is recommended that a more traditional two way pavement crossfall be required with the stormwater drainage pipe on the uphill side of the road. Lateral pipes would then pick up the flows on the down hill side of the pavement. Alongside the stormwater pipe (in the same trench) a subsoil pipe should be provided. This will then intercept the subsurface water and direct it into the stormwater system before it gets under the pavement. This approach aligns with the recommended standard cross section for urban roads in the "Local Government Guidelines for Subdivisional Development" Edition 2, 2009, as shown below (p.53).
